**Test Report No. 608331-01-1A-2-3**

## **MASH TL-4 EVALUATION OF 2019 MASH 2-TUBE BRIDGE RAIL**

### **TEXAS A&M TRANSPORTATION INSTITUTE PROVING GROUND**

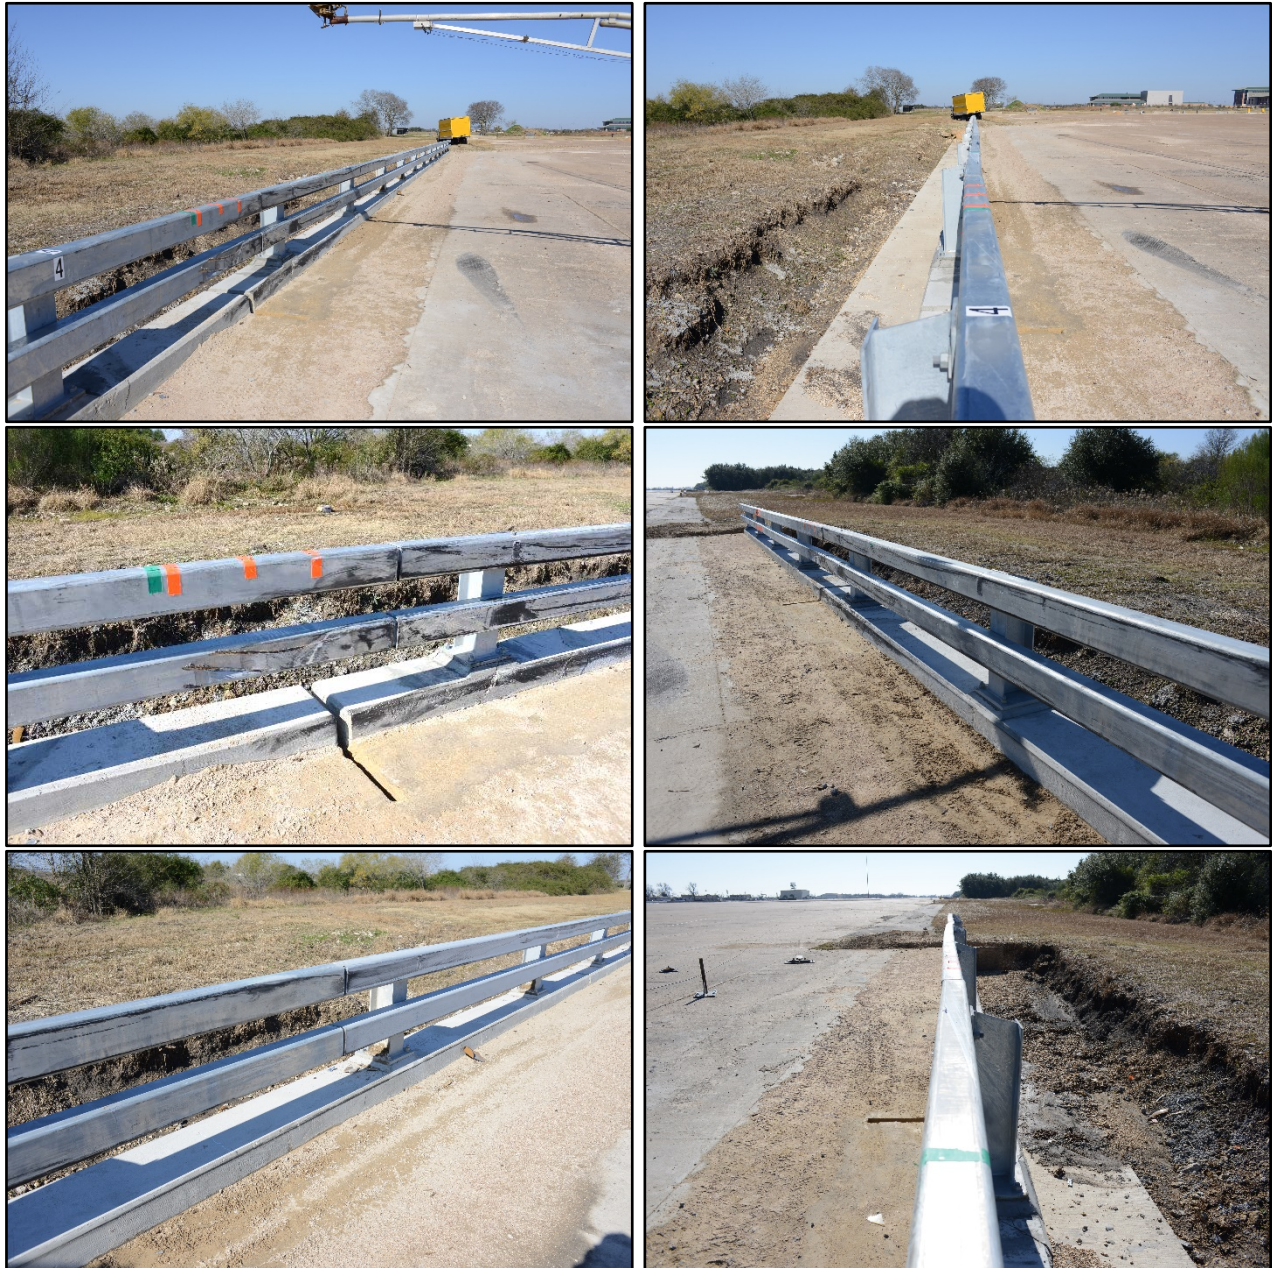
Figures 5.3 and 5.4 show the damage to the 2019 MASH 2-Tube Bridge Rail. The traffic face of the bridge rail was scuffed with tire marks, and the lower rail element was gouged in the impact area. The curb was cracked on the downstream side of post 5 and just upstream of post 5 (see Figure 5.4). Working width was 56.7 inches at a height of 136.8 inches. Maximum

dynamic deflection during the test was 3.0 inches, and maximum permanent deformation was 2.0 inches.

**Figure 5.3. Overall Damage to Alaska Bridge Rail after Test No. 608331-01-1A.**

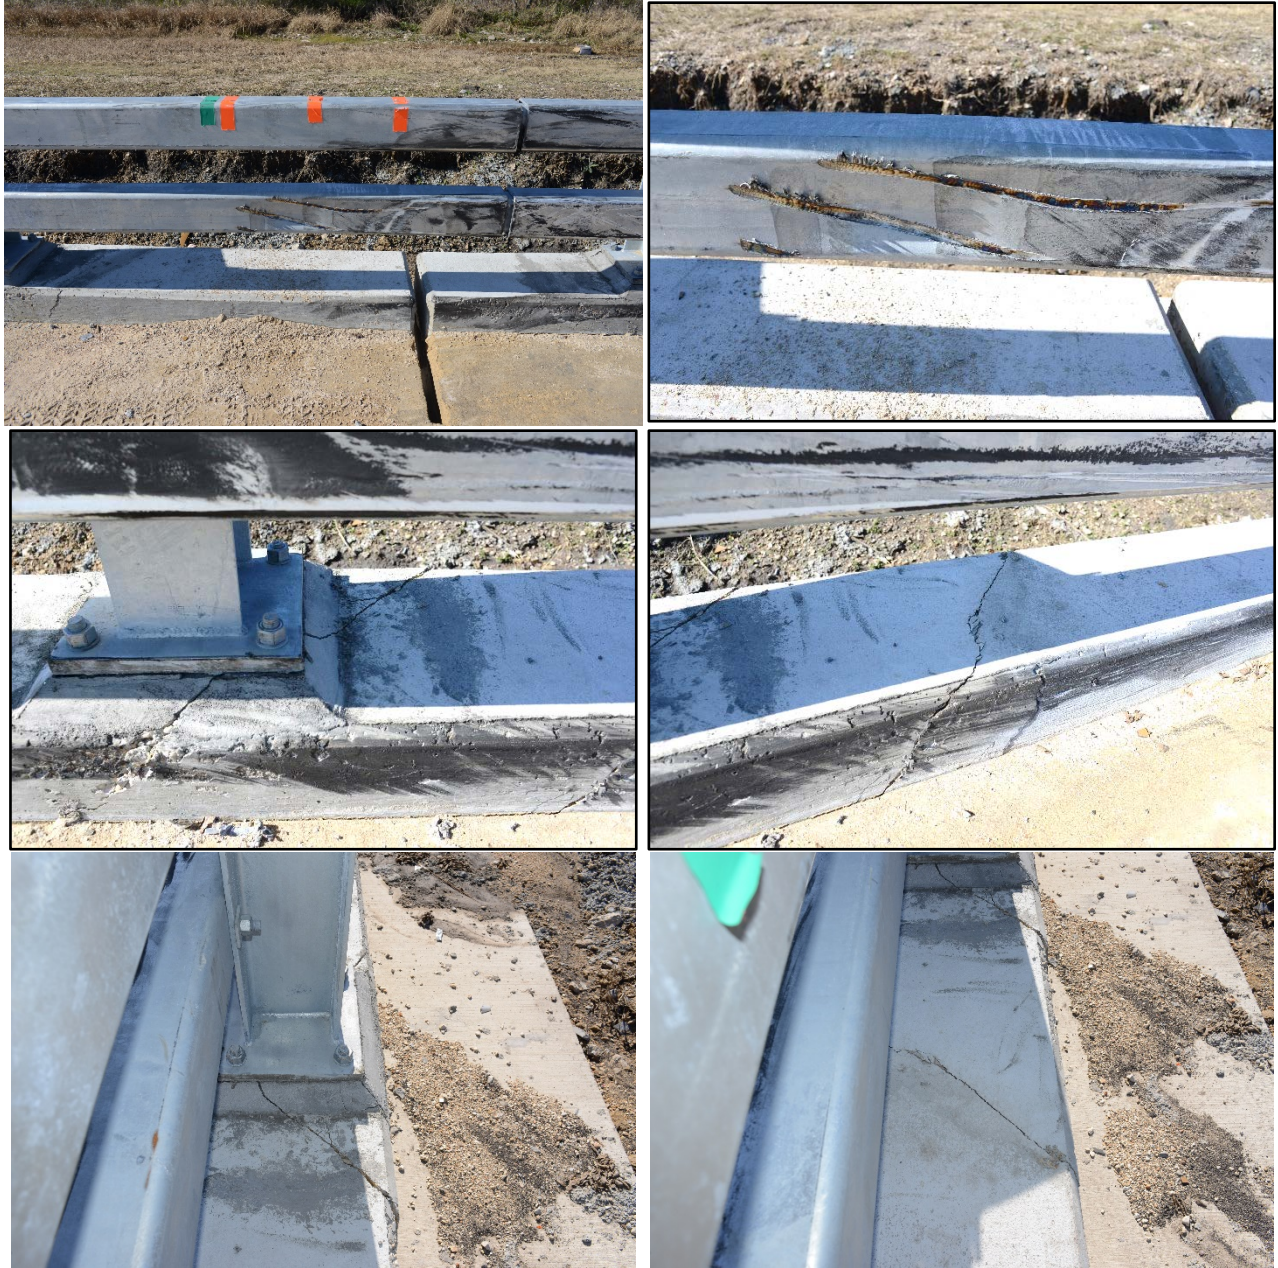
**Figure 5.4. Impact Area after Test No. 608331-01-1A.**

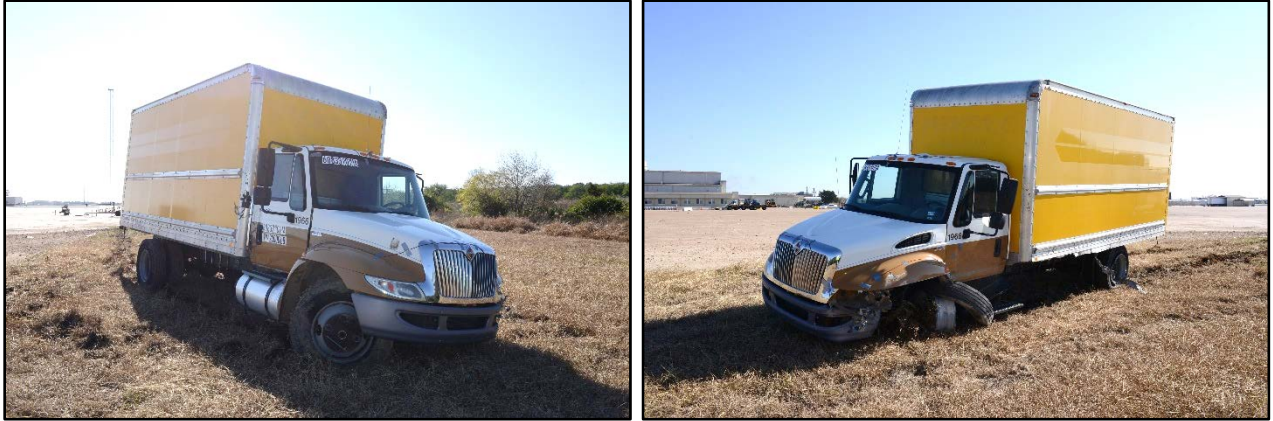
Figure 5.5 shows the damage sustained by the vehicle. The front bumper, hood, left front tire and rim, left front U-bolts, left battery box, left side steps, left door, left rear cab corner, lower edge of box, and left rear outer tire and rim were damaged. Maximum exterior crush to the vehicle was 12.0 inches in the front plane at the left front corner at bumper height. Maximum occupant compartment deformation was 5.5 inches in the left front corner of the floor pan. Figure 5.6 shows the interior of the vehicle.

**Figure 5.5. Test Vehicle after Test No. 608331-01-1A.**

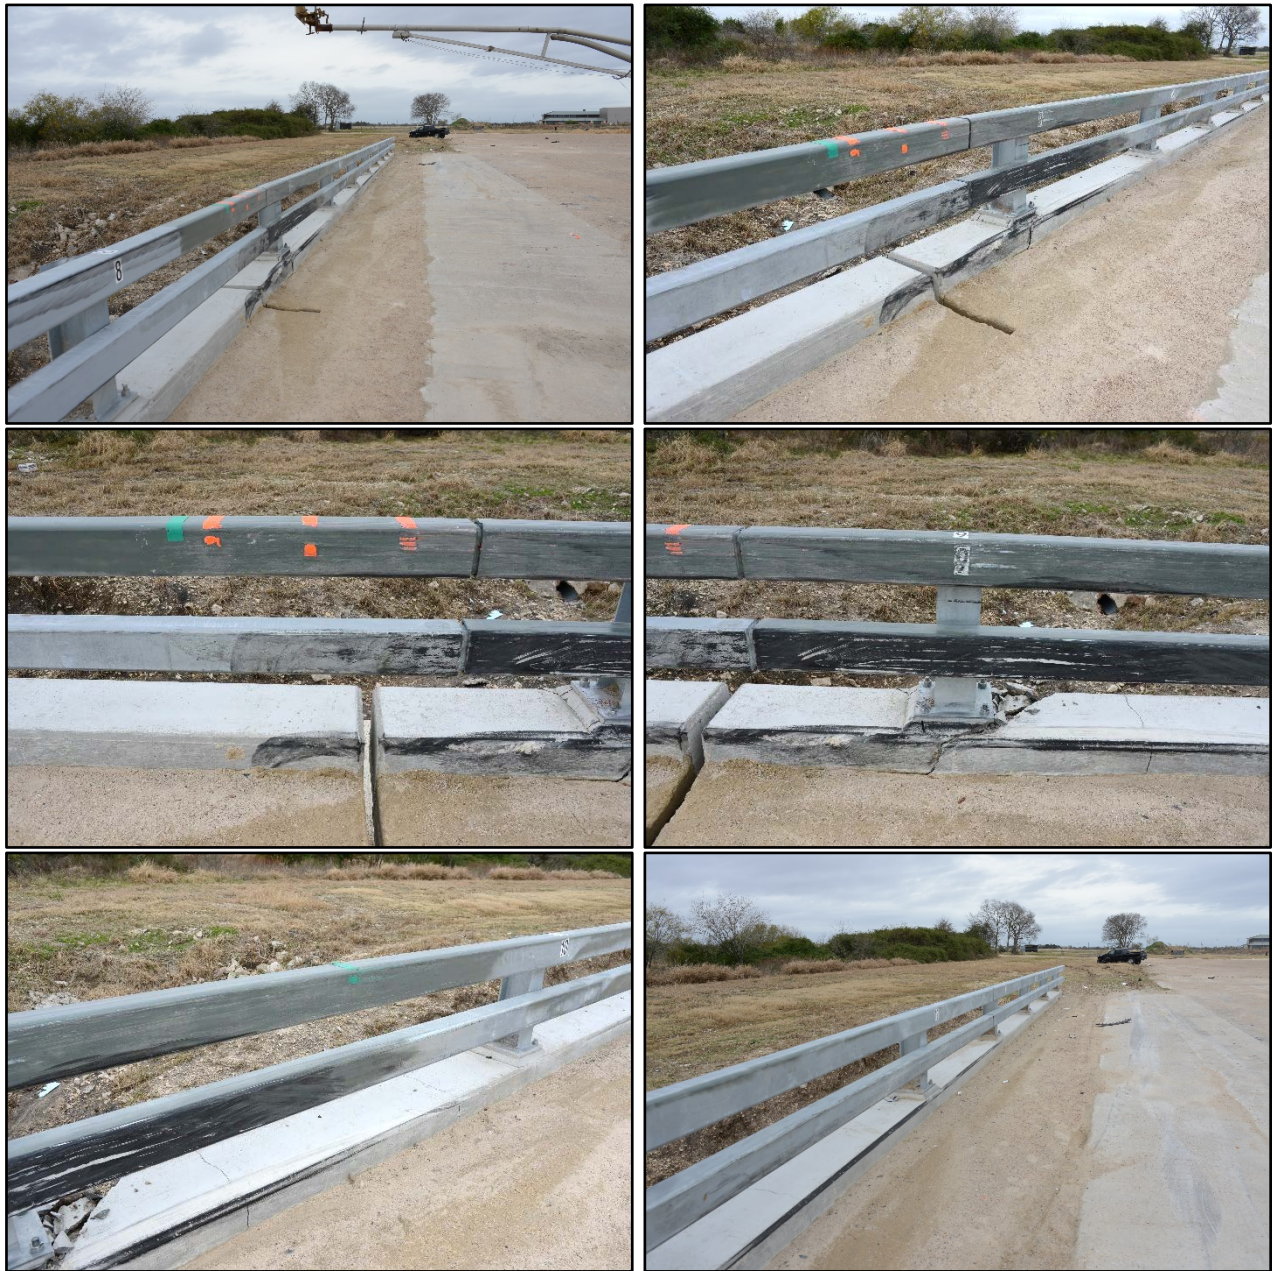
Figures 6.3 and 6.4 show the damage to the 2019 MASH 2-Tube Bridge Rail. The metal rail elements were scuffed with tire marks and cosmetic damage. The concrete around the curb at post 8 was cracked. The concrete around post 9 was cracked and spalled off, revealing the rebar on the field side of the curb and on the underside of the deck. Working width was 20.2 inches at the top of post 9. Maximum dynamic deflection during the test was 7.1 inches, and maximum permanent deformation was 2.0 inches.

**Figure 6.3. 2019 MASH 2-Tube Bridge Rail after Test No. 608331-01-2.**

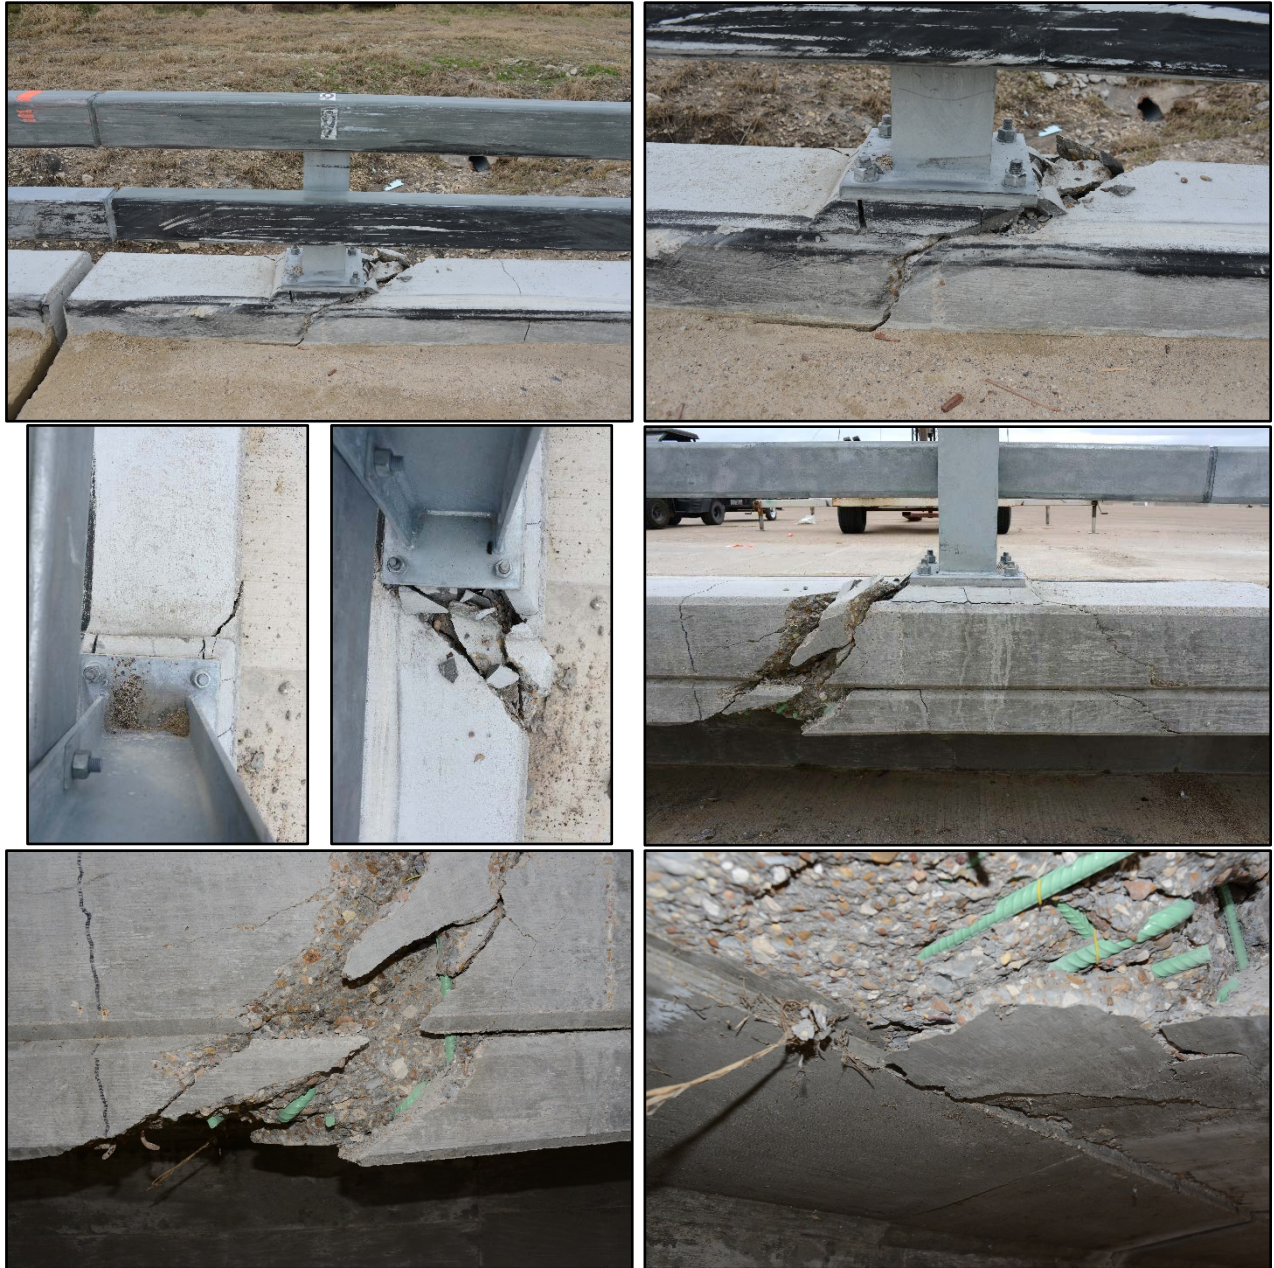
**Figure 6.4. Damage at Post 9 after Test No. 608331-01-2.**

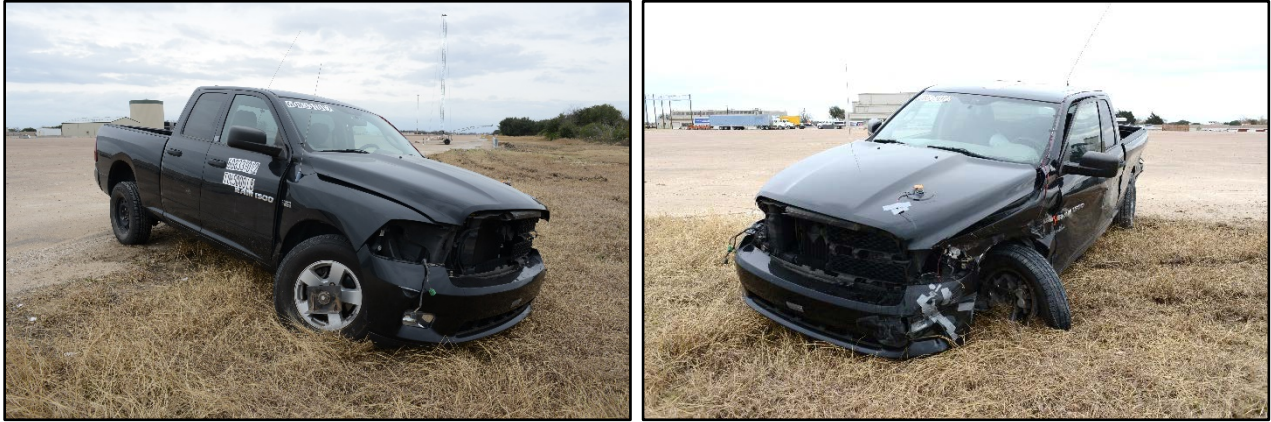
Figure 6.5 shows the damage sustained by the vehicle. The front bumper, hood, grill, left tire and rim, left upper and lower A-arms, left upper and lower ball joints, left tie rod end, left front fender, left front and rear doors, left rear cab corner, left rear exterior bed, left rear rim, rear bumper, and tailgate were damaged. The windshield sustained stress cracks radiating up and out from the left lower corner. Maximum exterior crush to the vehicle was 11.0 inches in the side plane at the left front corner at bumper height. Maximum occupant compartment deformation

was 0.5 inch in the left front firewall area. Figure 6.6 shows the interior of the vehicle. Tables D.3 and D.4 in Appendix D1 provide exterior crush and occupant compartment measurements.

**Figure 6.5. Test Vehicle after Test No. 608331-01-2.**

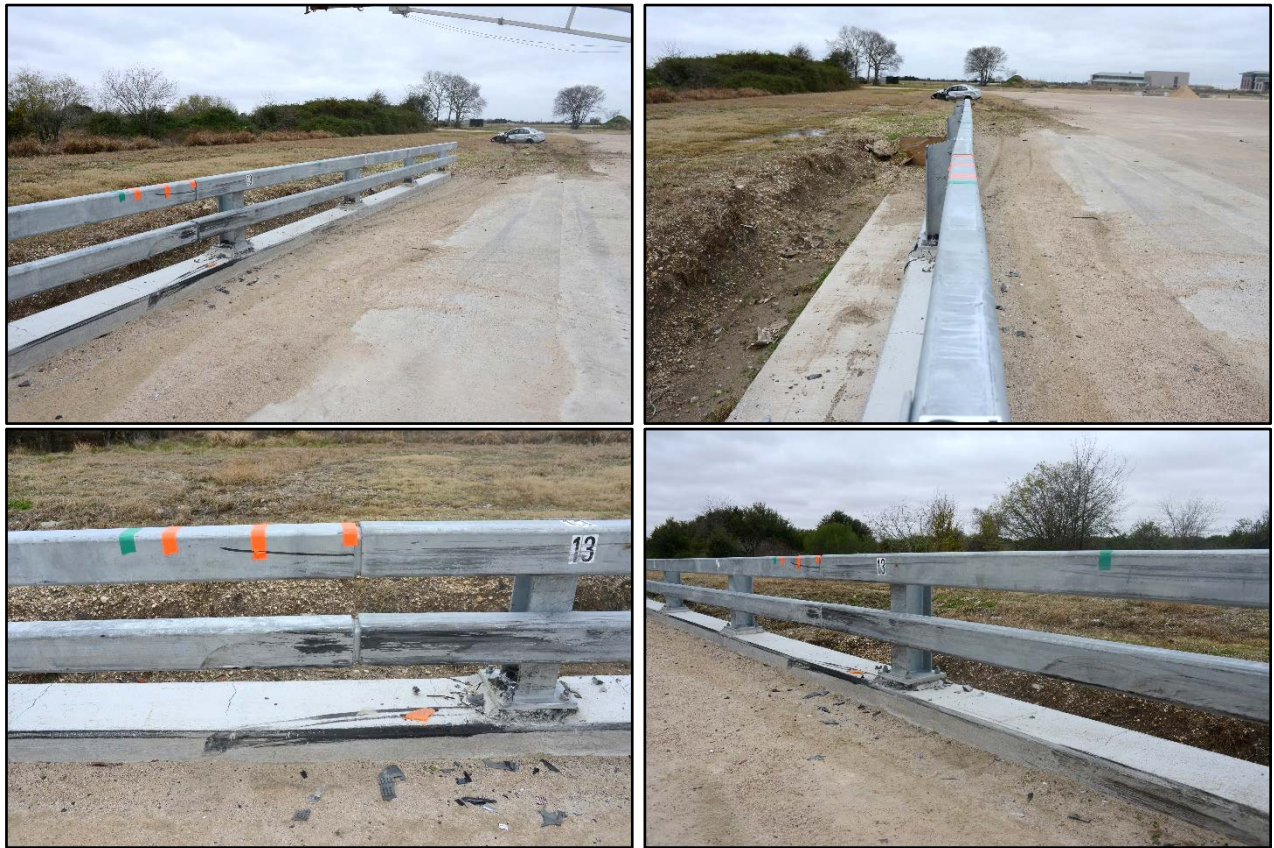
Figure 7.3 and 7.4 show the damage to the 2019 MASH 2-Tube Bridge Rail. The metal rail elements were scuffed with tire marks and cosmetic damage. The concrete around the base

of post 13 was broken through the curb on both sides of the post and extended to the bottom of the deck. Working width was 8.5 inches at a height of 44.3 inches. Maximum dynamic deflection during the test was 2.8 inches, and maximum permanent deformation was 1.0 inch.

**Figure 7.3. 2019 MASH 2-Tube Bridge Rail after Test No. 608331-01-3.**

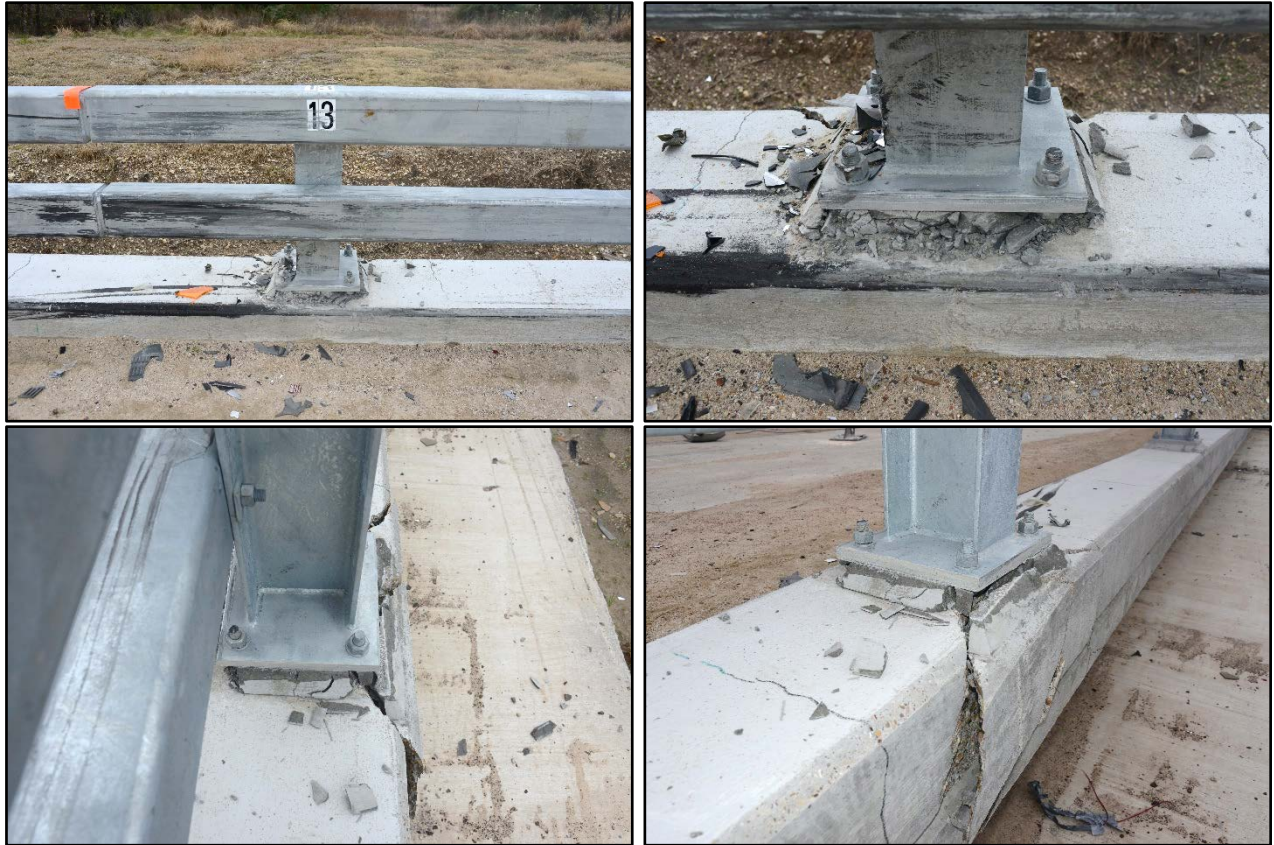
**Figure 7.4. Damage at Post 13 after Test No. 608331-01-3.**

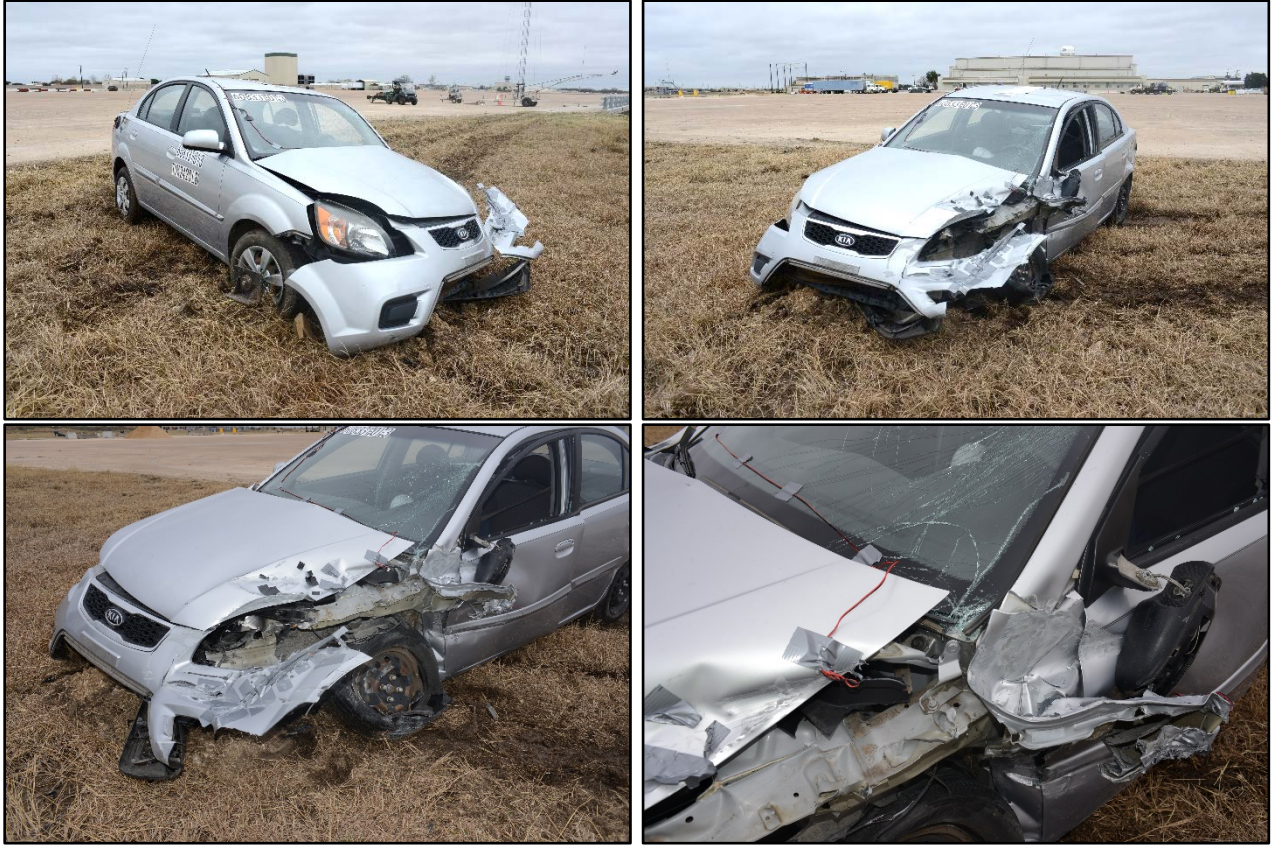
Figure 7.5 shows the damage sustained by the vehicle. The front bumper, hood, radiator and support, left front fender, left front tire and rim, left front strut and tower, left A-post, roof, left front door and window glass, left rear door, left rear quarter panel, and rear bumper were damaged. The windshield sustained stress cracks radiating upward and outward from the left lower corner. Maximum exterior crush to the vehicle was 11.0 inches in the side plane at the left front corner at bumper height. Maximum occupant compartment deformation was 4.0 inches in the left front firewall area. Figure 7.6 shows the interior of the vehicle. Tables E.2 and E.3 in Appendix E1 provide exterior crush and occupant compartment measurements.

**Figure 7.5. Test Vehicle after Test No. 608331-01-3.**
