**Test Report No. 608331-01-1A-2-3**

## **MASH TL-4 EVALUATION OF 2019 MASH 2-TUBE BRIDGE RAIL**

### **TEXAS A&M TRANSPORTATION INSTITUTE PROVING GROUND**

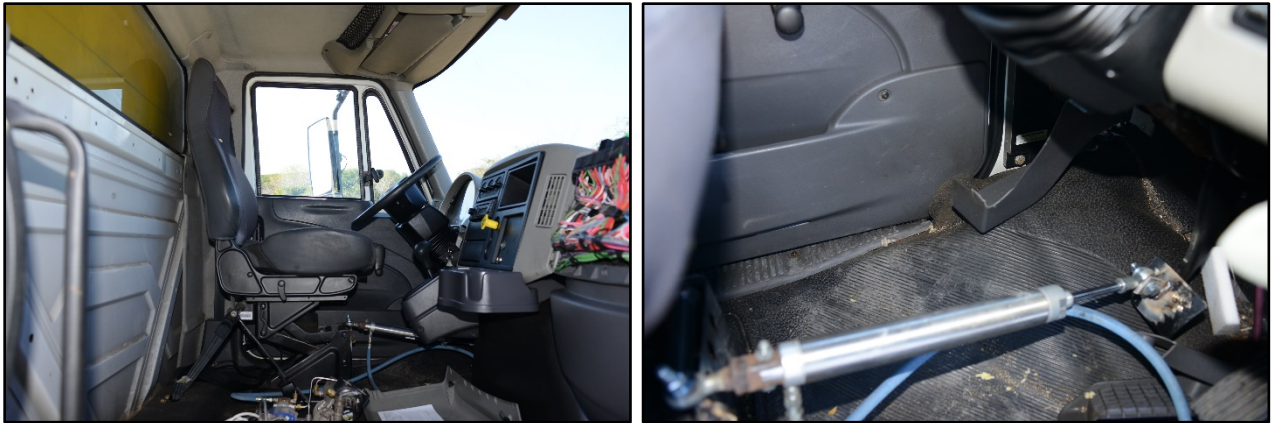
**Figure 5.6. Interior of Test Vehicle after Test No. 608331-01-1A.**

Figure 5.5 shows the damage sustained by the vehicle. The front bumper, hood, left front tire and rim, left front U-bolts, left battery box, left side steps, left door, left rear cab corner, lower edge of box, and left rear outer tire and rim were damaged. Maximum exterior crush to the vehicle was 12.0 inches in the front plane at the left front corner at bumper height. Maximum occupant compartment deformation was 5.5 inches in the left front corner of the floor pan. Figure 5.6 shows the interior of the vehicle.

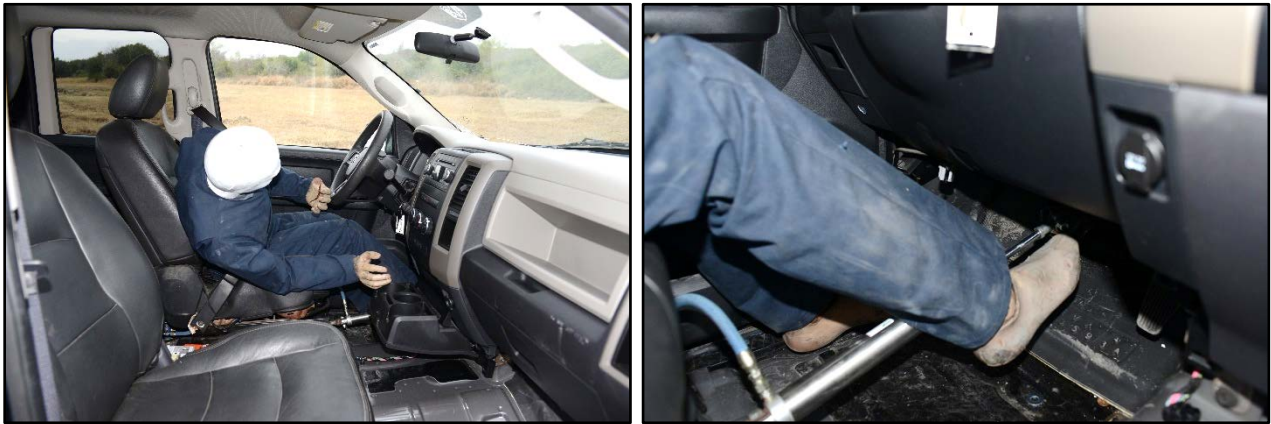
**Figure 6.6. Interior of Test Vehicle for Test No. 608331-01-2.**

Figure 6.5 shows the damage sustained by the vehicle. The front bumper, hood, grill, left tire and rim, left upper and lower A-arms, left upper and lower ball joints, left tie rod end, left front fender, left front and rear doors, left rear cab corner, left rear exterior bed, left rear rim, rear bumper, and tailgate were damaged. The windshield sustained stress cracks radiating up and out from the left lower corner. Maximum exterior crush to the vehicle was 11.0 inches in the side plane at the left front corner at bumper height. Maximum occupant compartment deformation

was 0.5 inch in the left front firewall area. Figure 6.6 shows the interior of the vehicle. Tables D.3 and D.4 in Appendix D1 provide exterior crush and occupant compartment measurements.

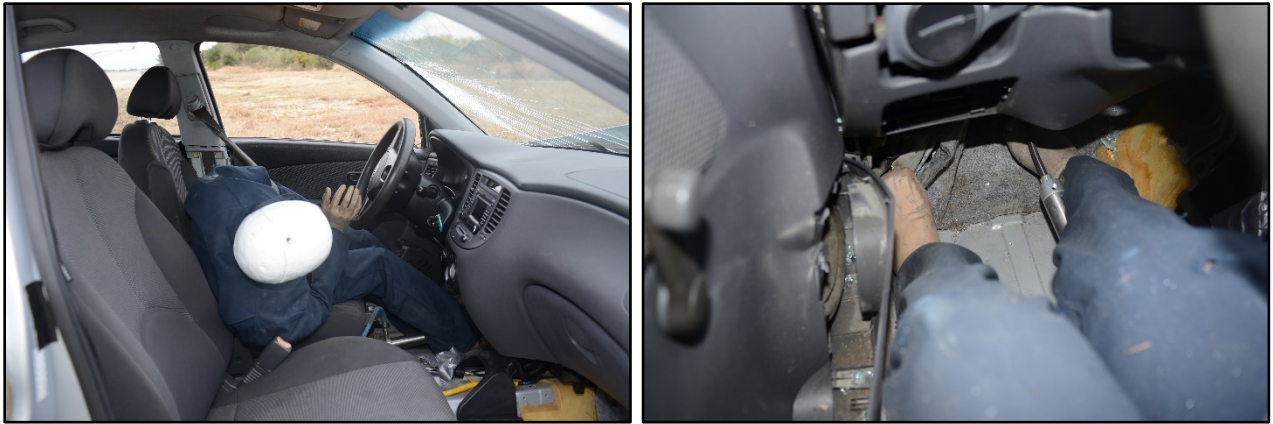
**Figure 7.6. Interior of Test Vehicle for Test No. 608331-01-3.**

Figure 7.5 shows the damage sustained by the vehicle. The front bumper, hood, radiator and support, left front fender, left front tire and rim, left front strut and tower, left A-post, roof, left front door and window glass, left rear door, left rear quarter panel, and rear bumper were damaged. The windshield sustained stress cracks radiating upward and outward from the left lower corner. Maximum exterior crush to the vehicle was 11.0 inches in the side plane at the left front corner at bumper height. Maximum occupant compartment deformation was 4.0 inches in the left front firewall area. Figure 7.6 shows the interior of the vehicle. Tables E.2 and E.3 in Appendix E1 provide exterior crush and occupant compartment measurements.
